Comments by Lilian on the alignment

Howard Matis
December 1, 2011

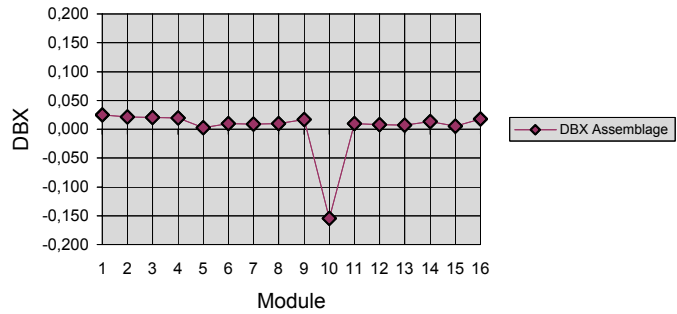
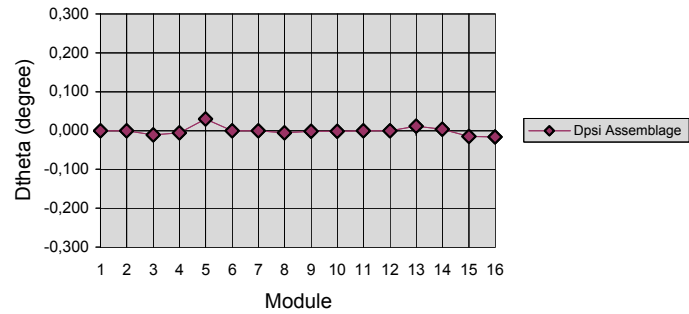
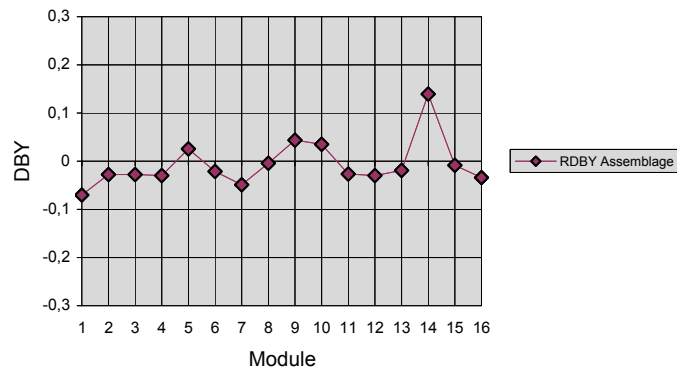
Ladder 16

Module 1 not measured (position taken when the module was installed on the bench)
 Module 14 shifted by 400 microns in Y (?)

No Z variation measured

- This ladder shows two particular defects
 - Module 10 is shifted by 150 μm in X
 - The position of the modules is irregular in Y with a maximum shift of 140 μm for module 14.
- Must correct for individual modules
 - In the X direction 20 μm is expected

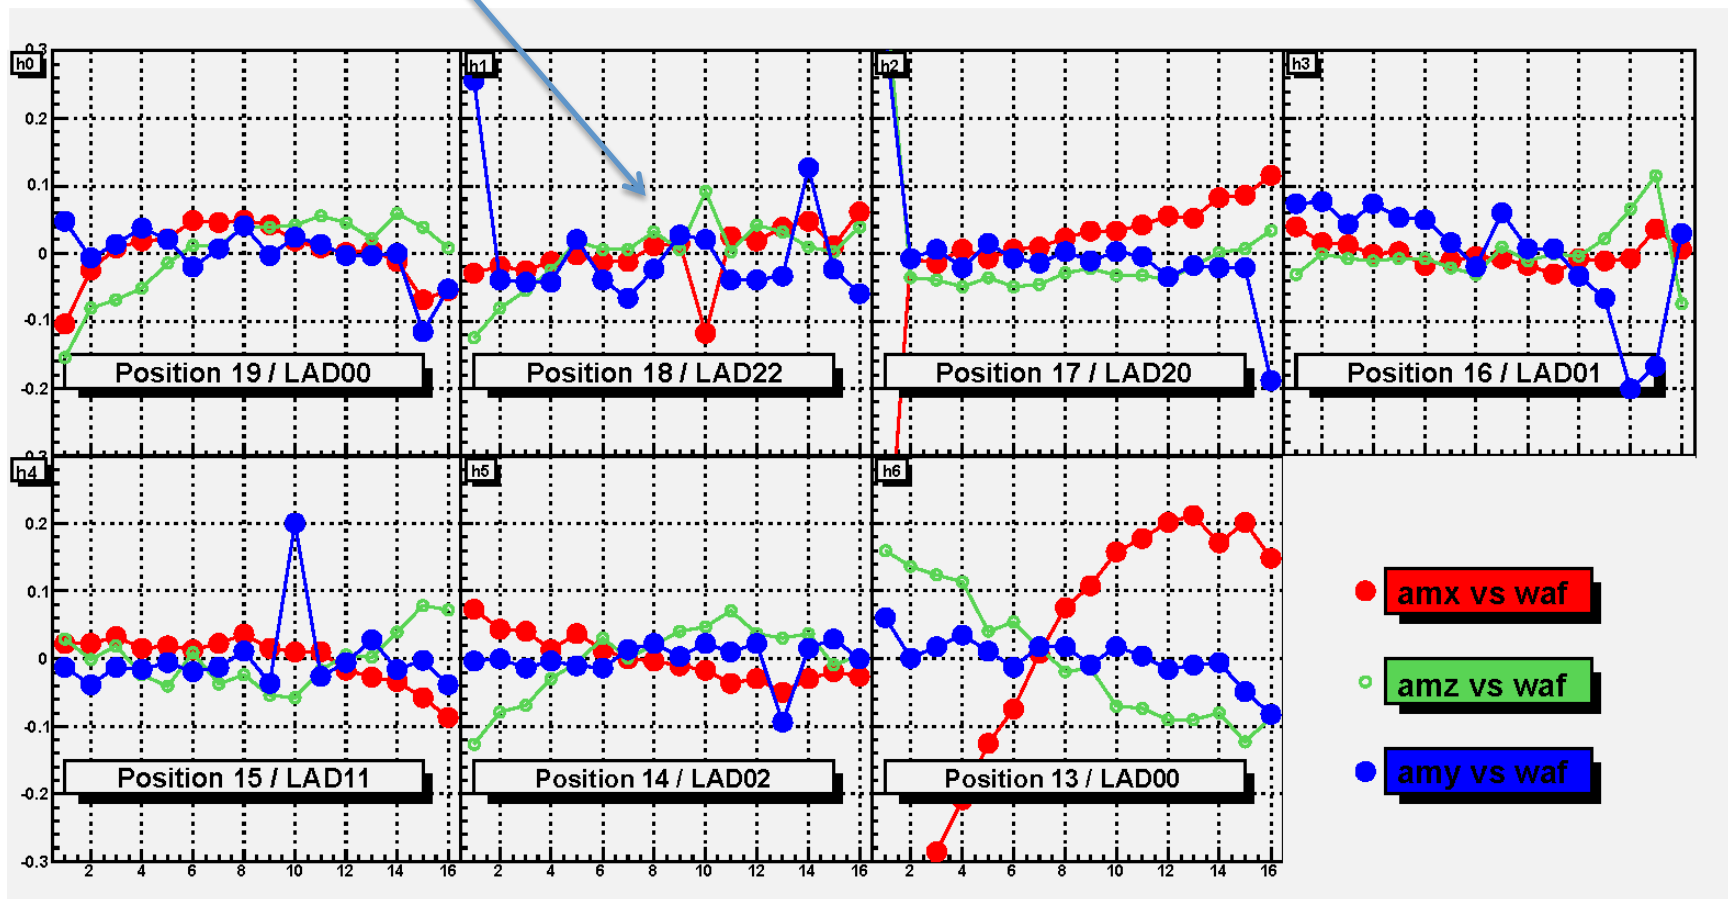
Ladder 22 – Looks different from before

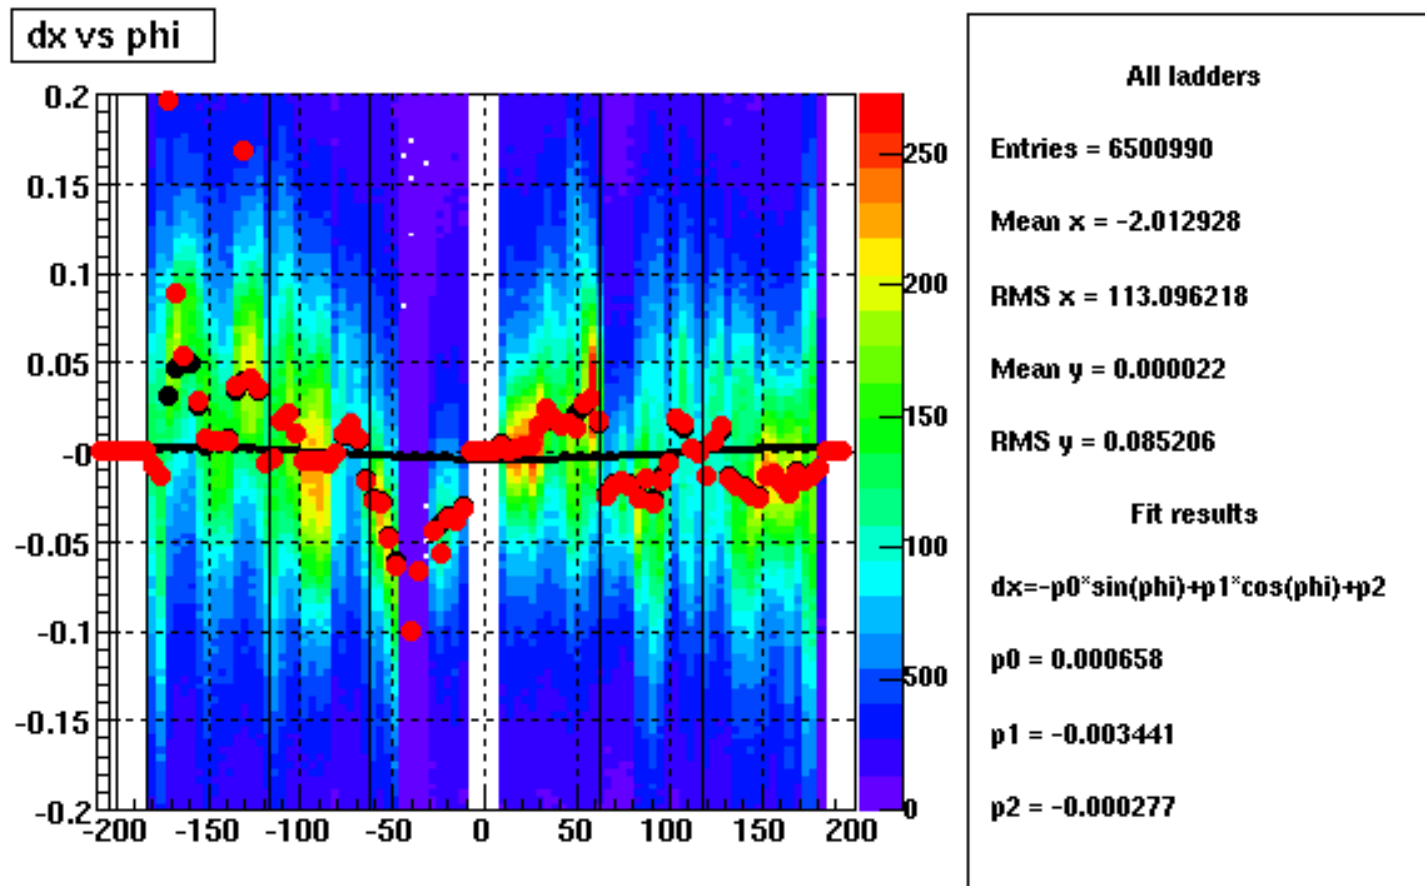
Pass 006 : Ladder radius corrections

All ladders on big sectors (3 to 9 and 13 to 19) had their radius overestimated by 2 mm except the ladder 16. The radii are corrected in this pass. The SSD geometry in the database matches the geometry obtained after this Pass.
