Performance and Plans for the Silicon Pixel Upgrade of the STAR Experiment at RHIC

Spiros Margetis¹

for the STAR Collaboration

The 2015 International Conference on
Applications of Nuclear Techniques

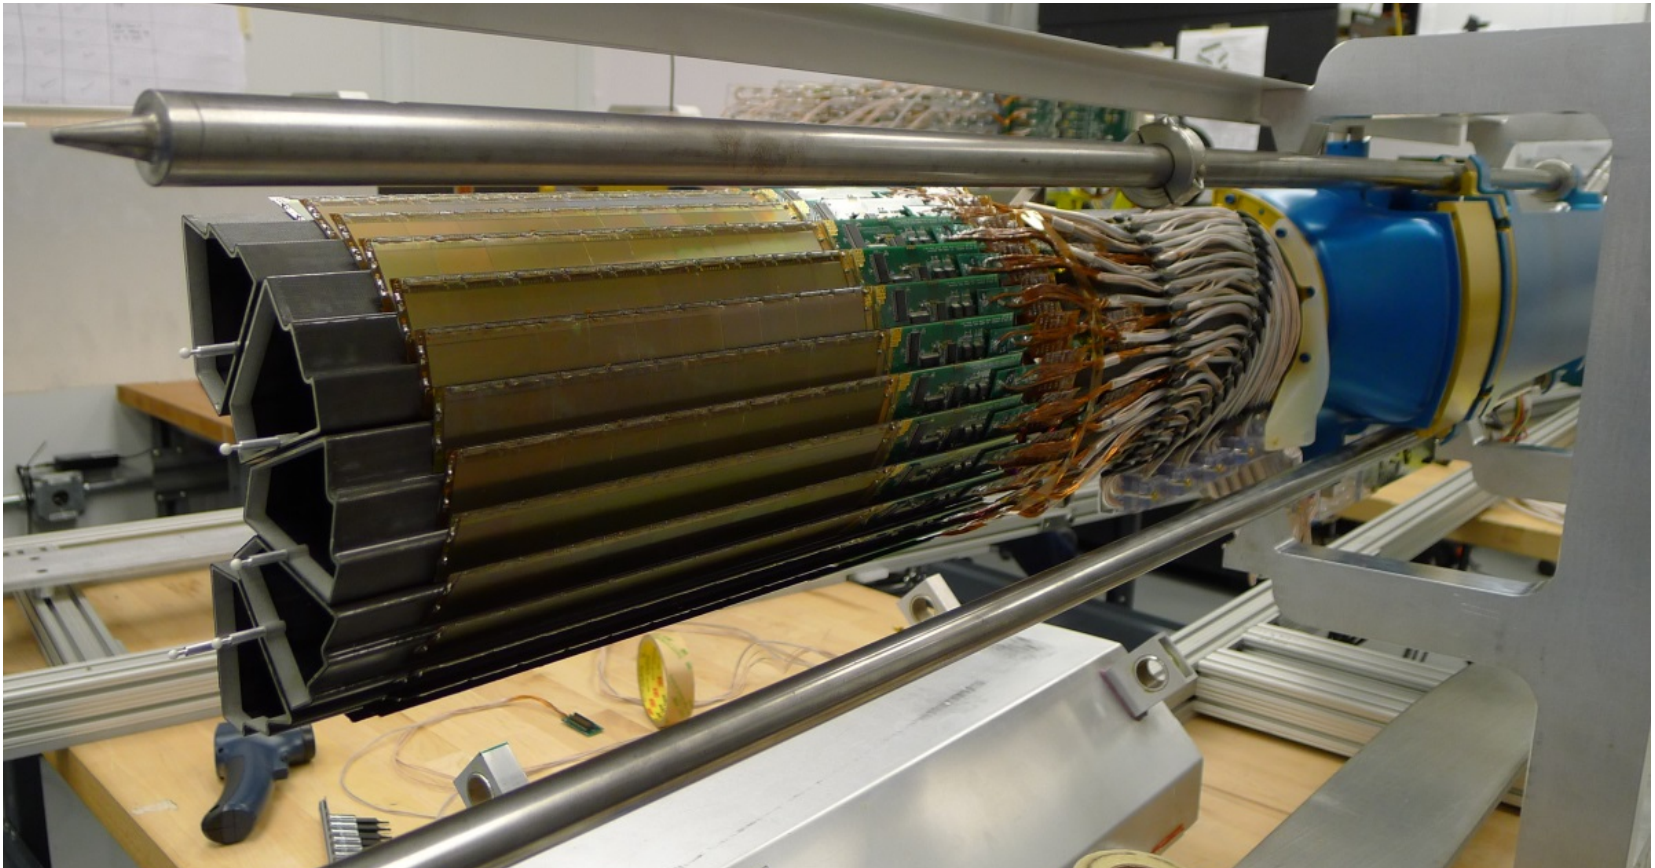
PXL characteristics

- MAPS sensors with $20.7 \mu\text{m}$ pitch
- Radius: ~ 2.8 and ~ 8 cm
- Radiation length $< 0.4\% X_0$ in inner layer

**first MAPS based vertex
detector at a collider
experiment**

DCA Pointing resolution *	(12 \oplus 24 GeV/p-c) μm
Layers	Layer 1 at 2.8 cm radius Layer 2 at 8 cm radius
Pixel size	20.7 μm X 20.7 μm
Hit resolution	3.7 μm (6 μm geometric)
Position stability	6 μm rms (20 μm envelope)
Radiation length first layer	$X/X_0 = 0.39\%$ (Al conductor cable)
Number of pixels	356 M
Integration time (affects pileup)	185.6 μs
Radiation environment	20 to 90 kRad / year $2 \cdot 10^{11}$ to 10^{12} 1MeV n eq/cm ²
Rapid detector replacement (hot spare copy of the detector)	~ 1 day

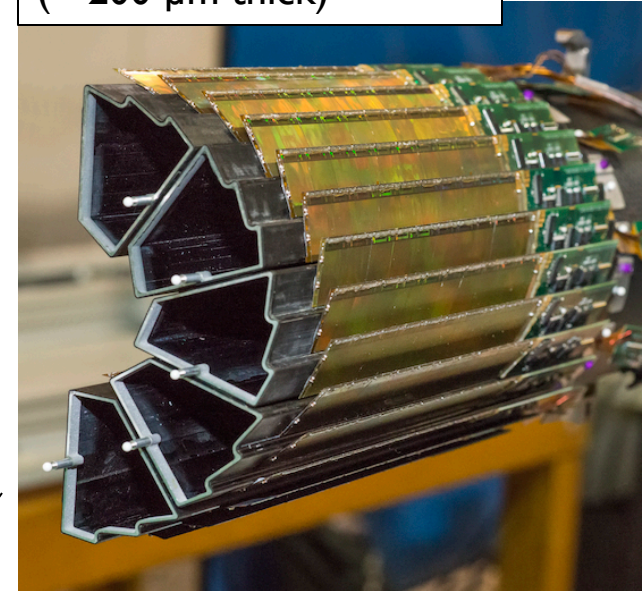
Ladder with 10 MAPS sensors (~ 2x2 cm each)

- ▶ Insertion from one side
- ▶ 10 sectors total
- ▶ 5 sectors / half
- ▶ 4 ladders / sector

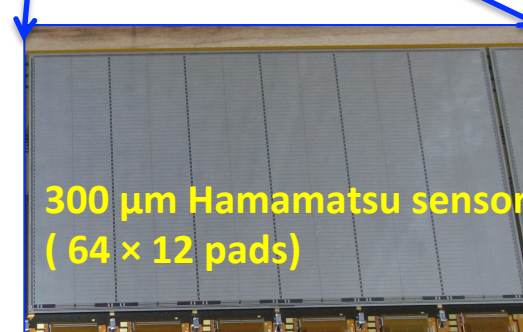
IST characteristics

ϕ -Coverage	2π
$ \eta $ -Coverage	≤ 1.2
Number of Staves	24
Number of hybrids	24
Number of sensors	144
Number of readout chips	864
Number of channels	110592
r - ϕ resolution	172 μm
Z resolution	1811 μm
R- ϕ pad size	594 μm
Z pad size	6275 μm

IST stave = Carbon fiber ladder
+ Kapton flex hybrid
+ Passive components
+ 6 silicon pad sensors
+ 3 x 12 APV25-S1 readout chips
+ Aluminum cooling tube
+ Liquid coolant (3M Novec 7200)

IST staves were assembled/tested/surveyed at UIC/
FNAL and MIT/BNL sites (18 staves produced at
each site).

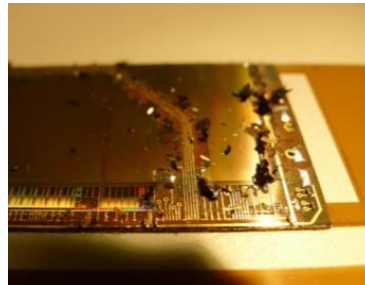
Flawed ladder dissection: searching for shorts

- ▶ Shorts between power and gnd, or LVDS outputs
- ▶ Adhesive layer extended in both dimensions to increase the portion coming out from underneath the sensors
- ▶ Insulating solder mask added to low mass cables

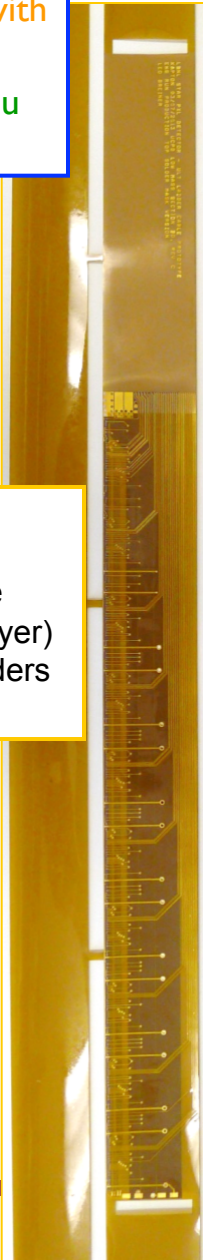
Flex cable
 (Copper version)

Cu conductor:
 $X/X_0 \uparrow$ to 0.129%
 (corrected for the thinner copper layer)
 \Rightarrow Cu based ladders
 $X/X_0 = 0.492\%$

NOTE: Does not include sector tube side walls
